Arborist Report

March 2009

Karen Christman, Certified Arborist (Certified Arborist #WE3807A)
ARBOR SERVICES *Hands On Tree Experts*
P.O. Box 3585, Santa Barbara, CA 93130 805-687-7779

RE: The Oak Cottage of Santa Barbara
1820, 1822, 1826 De La Vina Street
Santa Barbara, CA

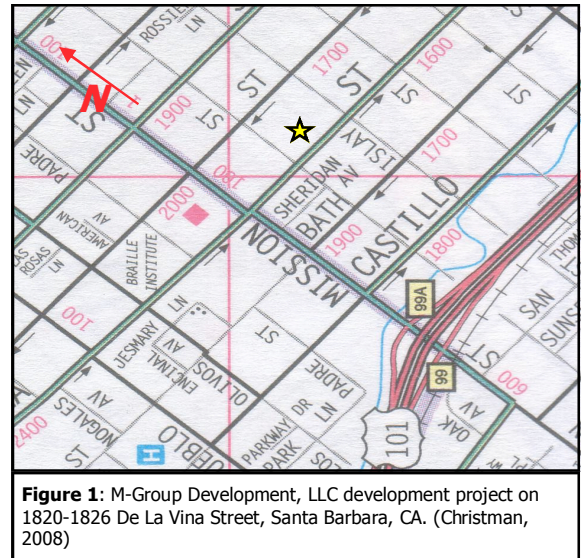
Figure 1: M-Group Development, LLC development project on 1820-1826 De La Vina Street, Santa Barbara, CA. (Christman, 2008)

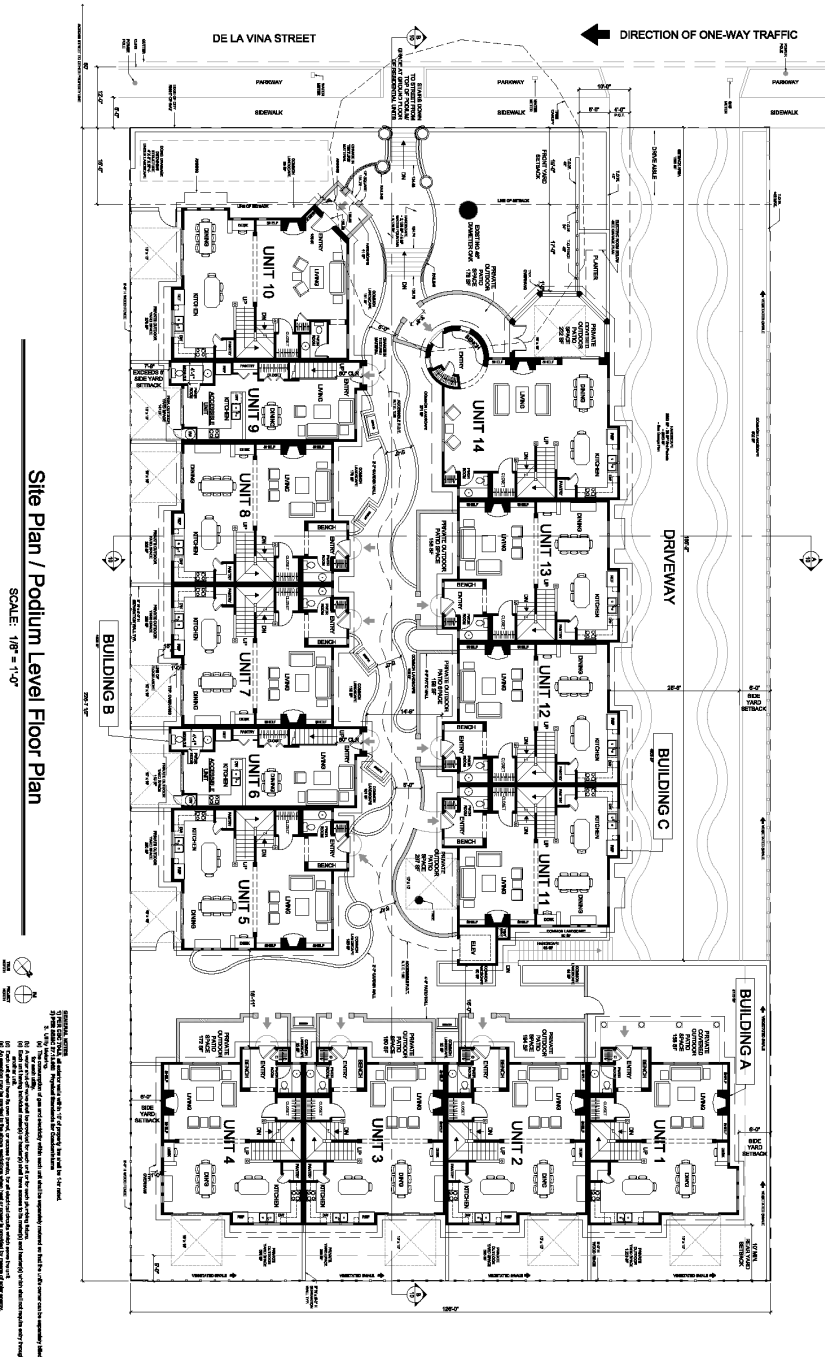
The outdoor patio area off of unit #14 approximately 14 feet to the east and walkway approximately 10 feet to the south of the subject Oak will be less severe (15% to 25% root loss in CRZ), especially if hardscape design such as bridging and materials such as permeable pavers are utilized to minimize root damage and soil compaction. Large roots are essential for tree stability and storage. In construction, they are typically damaged from excavation and trenching. Fine roots are required for water and nutrient uptake. These finer roots are easily damaged from soil compaction inflicted from grading or heavy foot traffic. Root loss symptoms include, but are not limited to, foliar and branch dieback, instability, reduced vigor, greater susceptibility to disease and pests, and epicormic growth.

APPENDIX III: Development Proposed within *Quercus agrifolia* CRZ
